# Manhole Inspection Summary

Manhole # S19M\_\_037MH

**Location** Address: **2030 PULASKI-PAYSON-ALLEY** Cross Street: **CHRISTIAN ST**

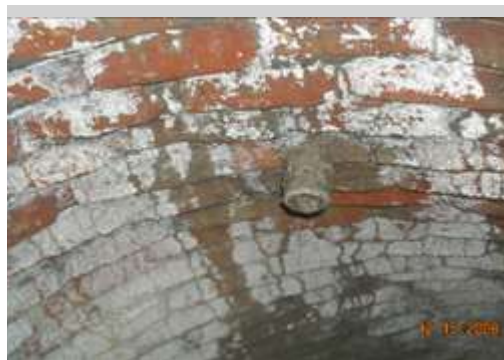
MISC.

UNKNOWN PIPE INTRUSION

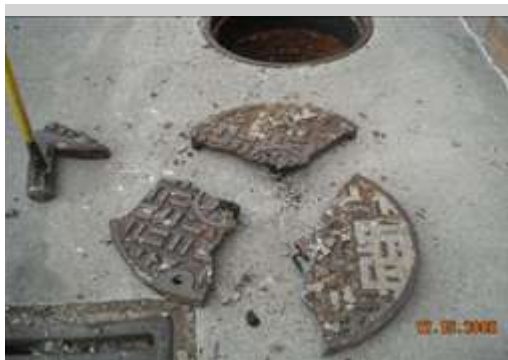
MISC.

Comments **BROKE & REPLACE COVER TO COMPLETE INSPECTION**

BROKE COVER TO GAIN ACCESS

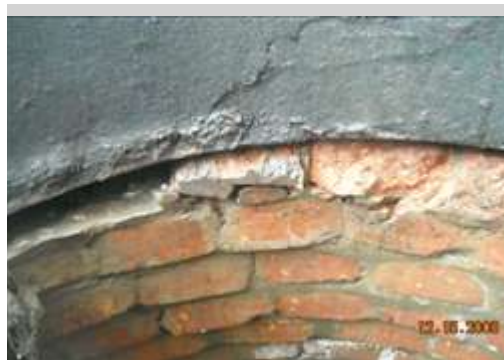
Defect 3

Condition: ☐ Sound ☒ **Cracked** ☐ Root Intrusion ☐ Loose Brick ☒ **Deteriorated**

CRACKED CORBEL BRICK

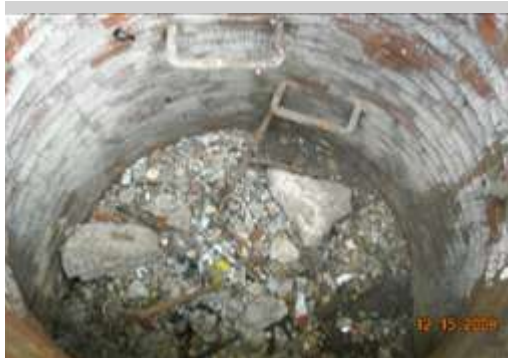
Defect 2

Condition: ☐ Sound ☐ Cracked ☐ Root Intrusion ☐ Deteriorated ☐ Leaks ☒ **Debris**

DEBRIS IN TERMINAL CHANNEL

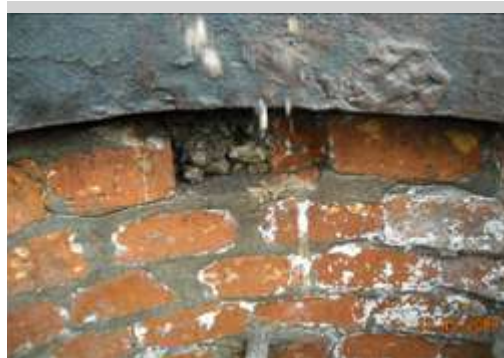
Defect 1

DETERIORATED CORBEL BRICK

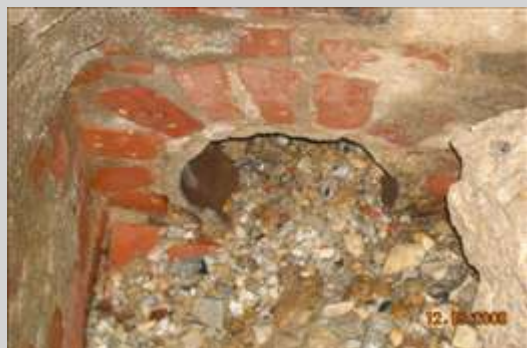
12 O'Clock Outflow

debris in pipe

Deposits: ☐ None ☒ **Mud** ☐ Sludge ☐ Debris ☐ Grease

Silt Depth: **2** (in.) Deposits Extent: **Light**
